**DEPARTMENT OF TRANSPORTATION**

Contract #: 04-0120F4Cty: SF/ALA Rte: 80 PM: 13.2/13.9File #: 69.28**WELDING INSPECTION REPORT****Resident Engineer:**Pursell, Gary**Address:** 333 Burma Road**City:** Oakland, CA 94607**Report No:** WIR-002406**Date Inspected:** 18-May-2008**Project Name:** SAS Superstructure**OSM Arrival Time:** 1400**Prime Contractor:** American Bridge/Fluor Enterprises, a JV**OSM Departure Time:** 2300**Contractor:** Zhenhua Port Machinery Company, Ltd (ZPMC), Changxing Island **Location:** Shanghai, China**CWI Name:** Chen Xi**CWI Present:** Yes No**Inspected CWI report:** Yes No N/A**Rod Oven in Use:** Yes No N/A**Electrode to specification:** Yes No N/A**Weld Procedures Followed:** Yes No N/A**Qualified Welders:** Yes No N/A**Verified Joint Fit-up:** Yes No N/A**Approved Drawings:** Yes No N/A**Approved WPS:** Yes No N/A**Delayed / Cancelled:** Yes No N/A**Bridge No:** 34-0006**Component:** OBG deck panels**Summary of Items Observed:**

OBG bay 1

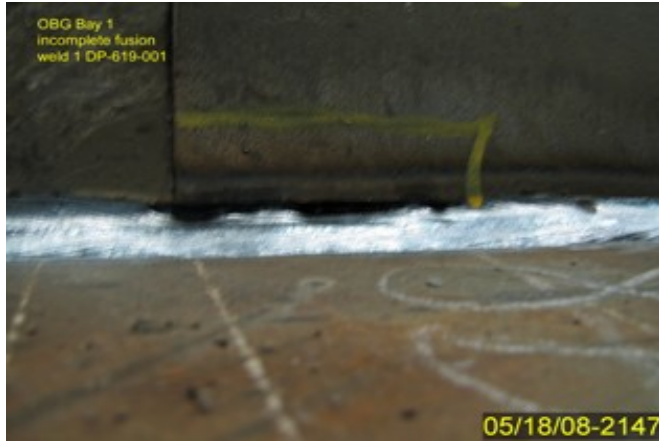
QA performed visual verification inspection for completed Partial Joint Penetration (PJP) U-rib to deck plate welds on deck panel DP-619-001 welds W1, W2 and W3. All welds that were inspected appeared to exhibit some degree of undercut, lack of fusion, overlap, oversize and/or under fill. All of the completed (PJP) welds joining U-Rib to deck plate that have been inspected on this panel do not appear to comply with the visual acceptance criteria specified in AWS D1.5 2002 and the contract documents.
